SAMPLING ACTIVITIES REPORT

R. J. REFINERY
La Barge, Wyoming

TDD No. 9804-0002

MARCH 30, 1999

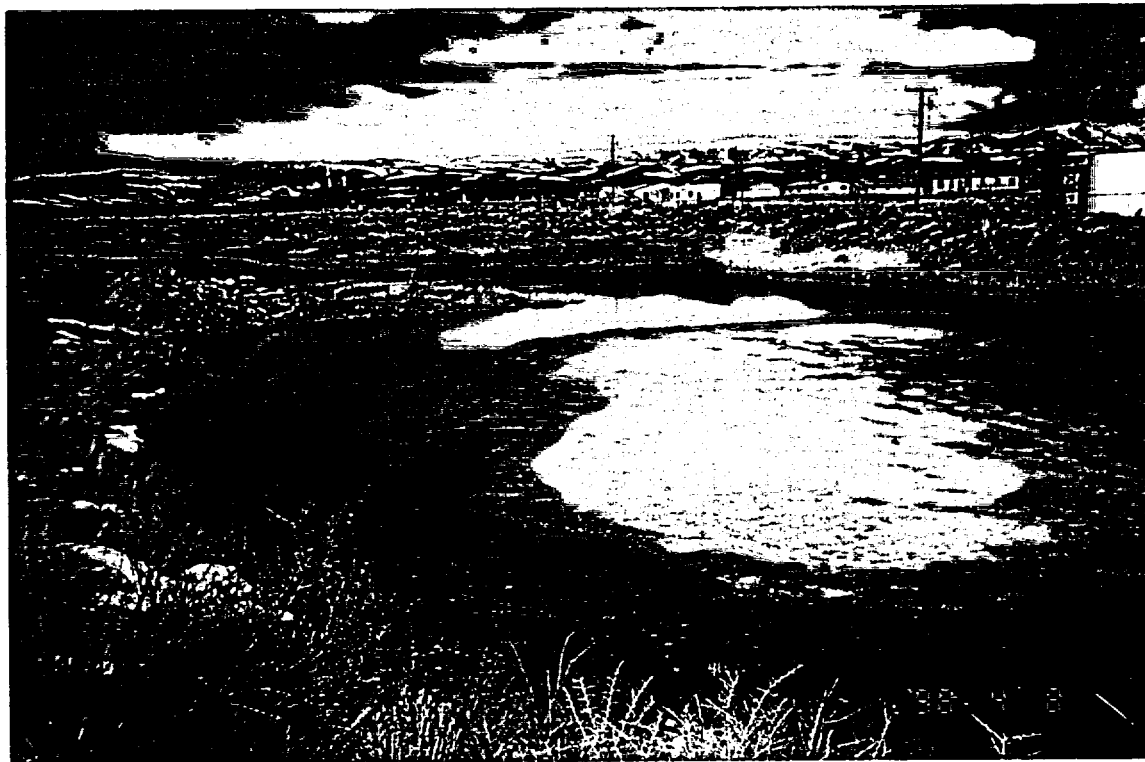
PHOTO 6

Prior to this site visit the refinery caretaker had mobilized a backhoe to the south side of the fire water pond located on the west side of the property. This pond water was designed for use in the event of a fire at the facility. The backhoe excavated an area along the central portion of the pond where two 55-gallon steel drums were reportedly buried. The excavation revealed only the outline of the drums and drum fragments. The former contents are unknown.

Facing northwest - view of the fire water pond. Drum excavation is located on the left.

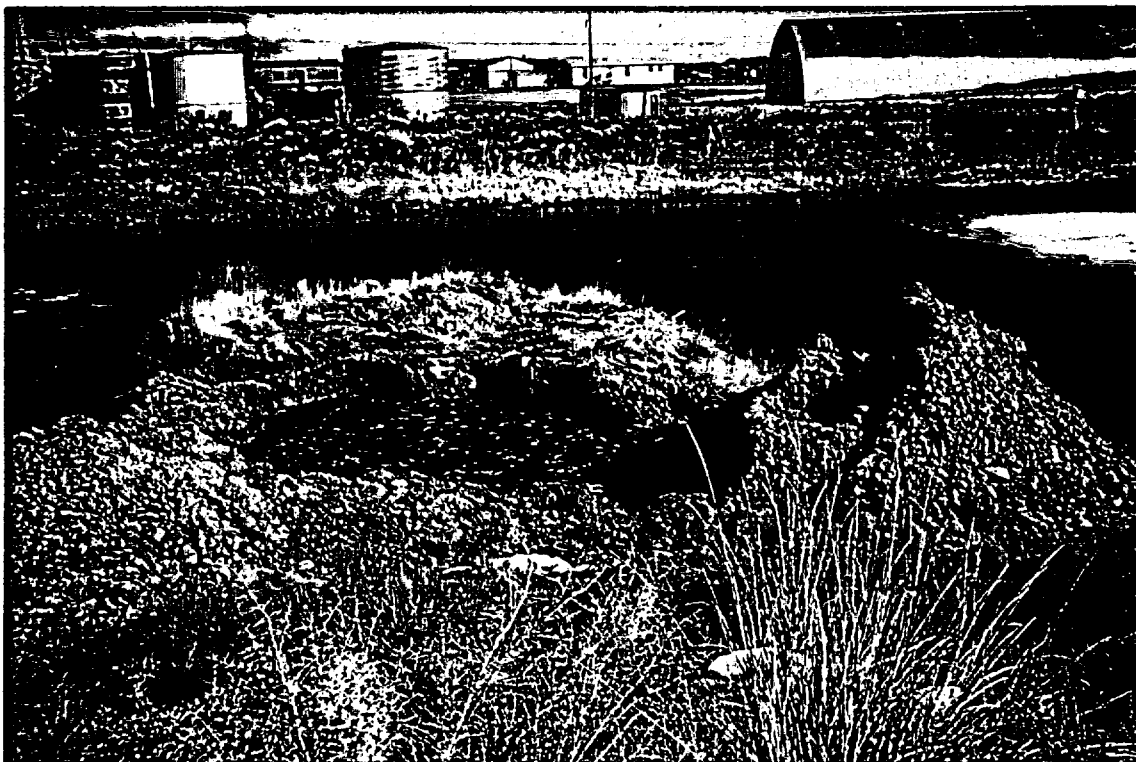
PHOTO 7

One soil sample (RJ-SO-06) was collected beneath approximately six inches of water within the drum excavation previously discussed. This sample was collected in an attempt to determine whether soil contamination had resulted from the former drum contents.

Facing north - excavation of two drums.

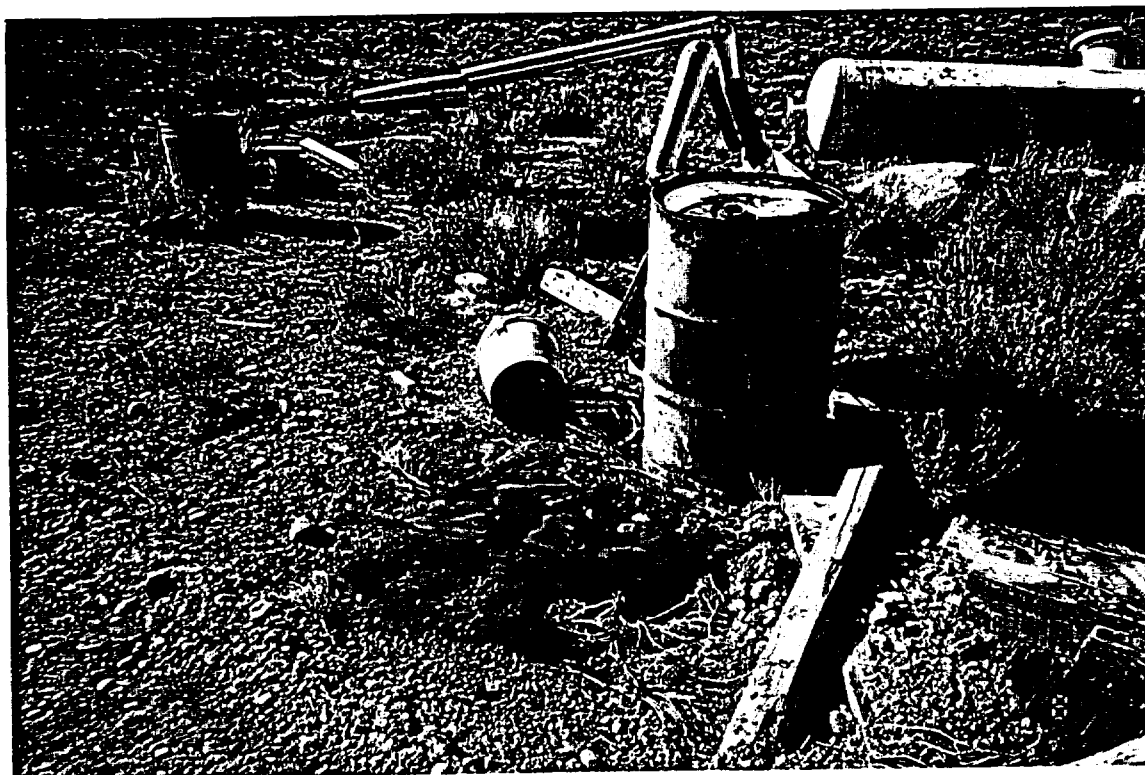
PHOTO 9

Facing south - leaking drum in the bone yard southwest of the southwest tank farm.

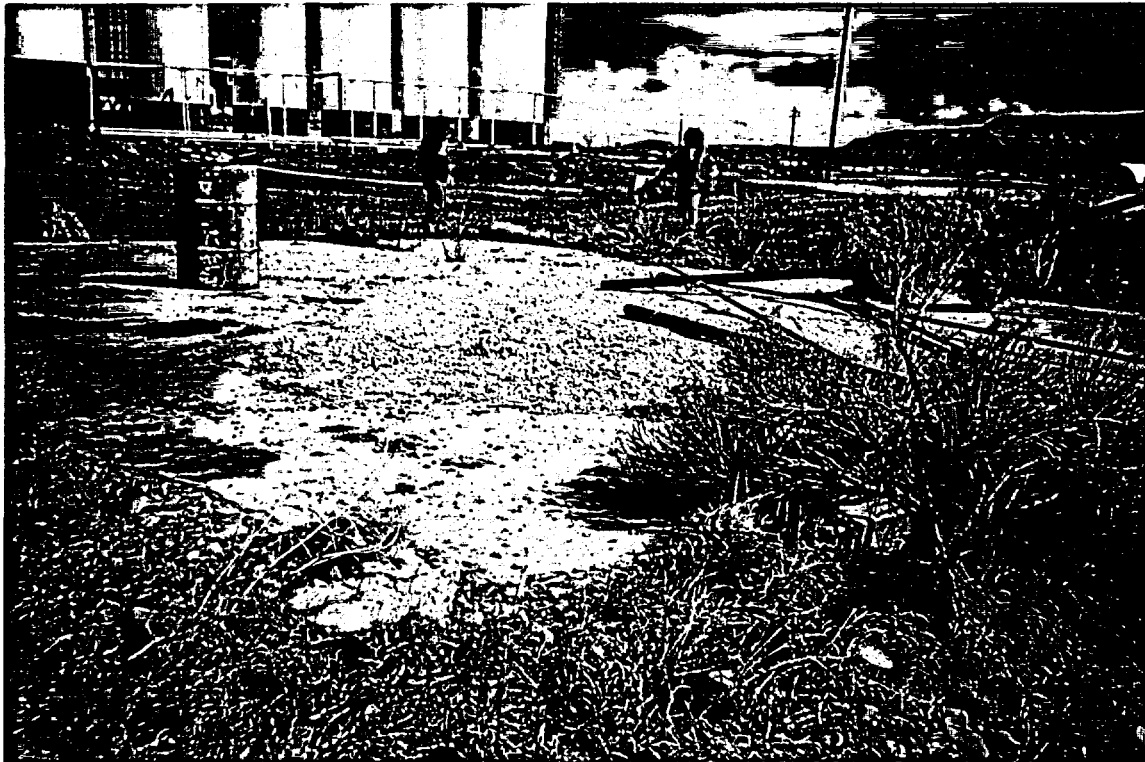
PHOTO 13

Drum sample RJ-PR-01 was reported with toluene, ethylbenzene, m,p-xylene, and o xylene at 1,200 micrograms per liter ($\mu\text{g/L}$), 8,300 $\mu\text{g/L}$, 41,000 $\mu\text{g/L}$, and 20,000 $\mu\text{g/L}$ respectively. The results are consistent with organic compounds found in diesel fuel dye (Table 5).

Facing northeast - sample RJ-PR-01 location from blue drum on northeast leading facility pad.

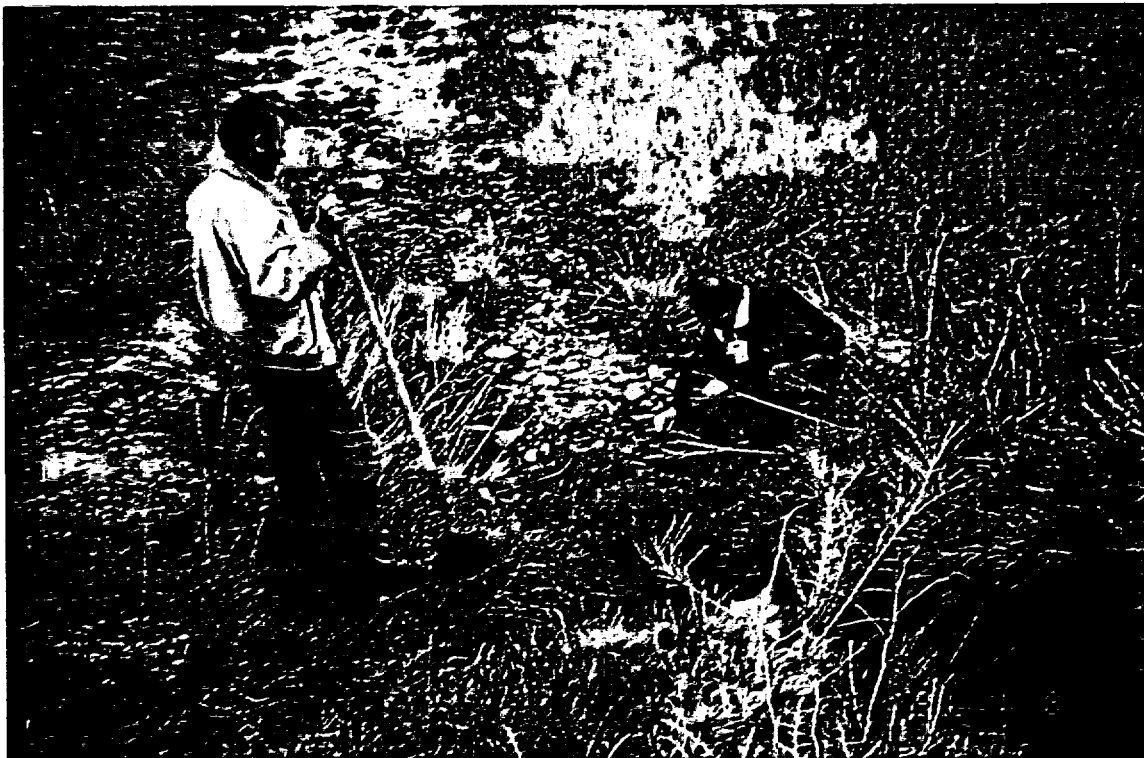
PHOTO 14

Facing east - sample RJ-PR-02 location of a sheen on water seepage.

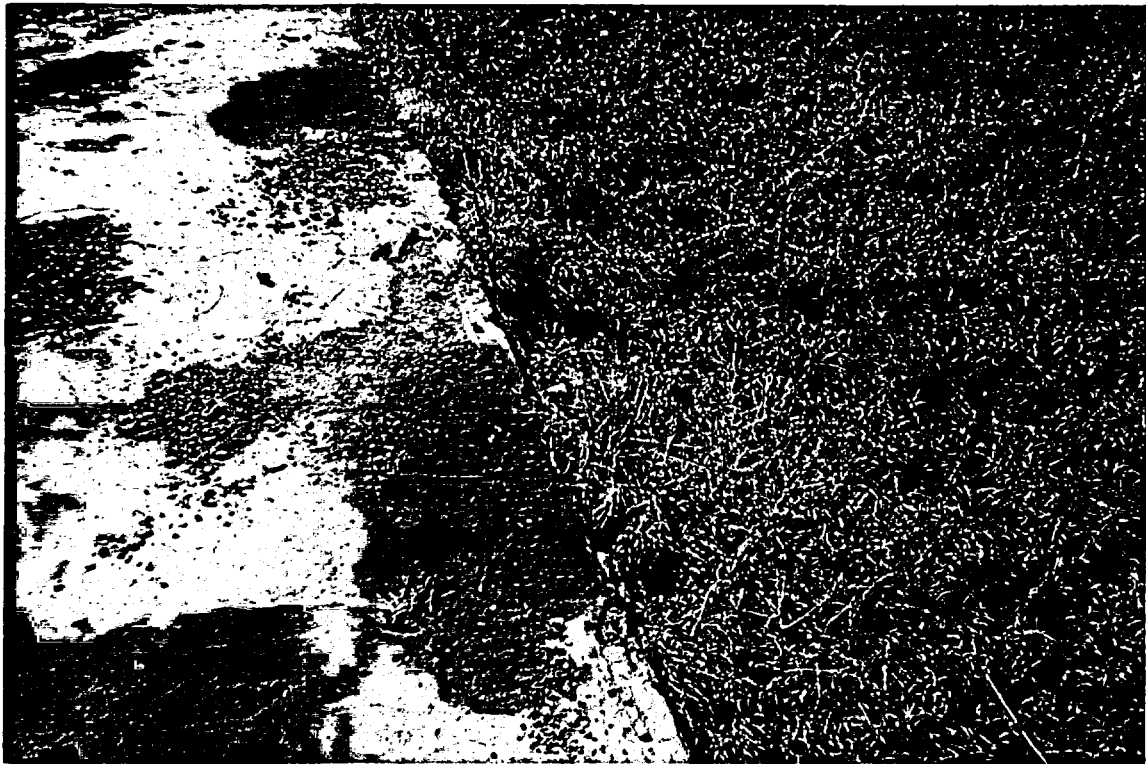
PHOTO 15

RJ-SO-01 sample location - stained soil around the northeast leading facility.

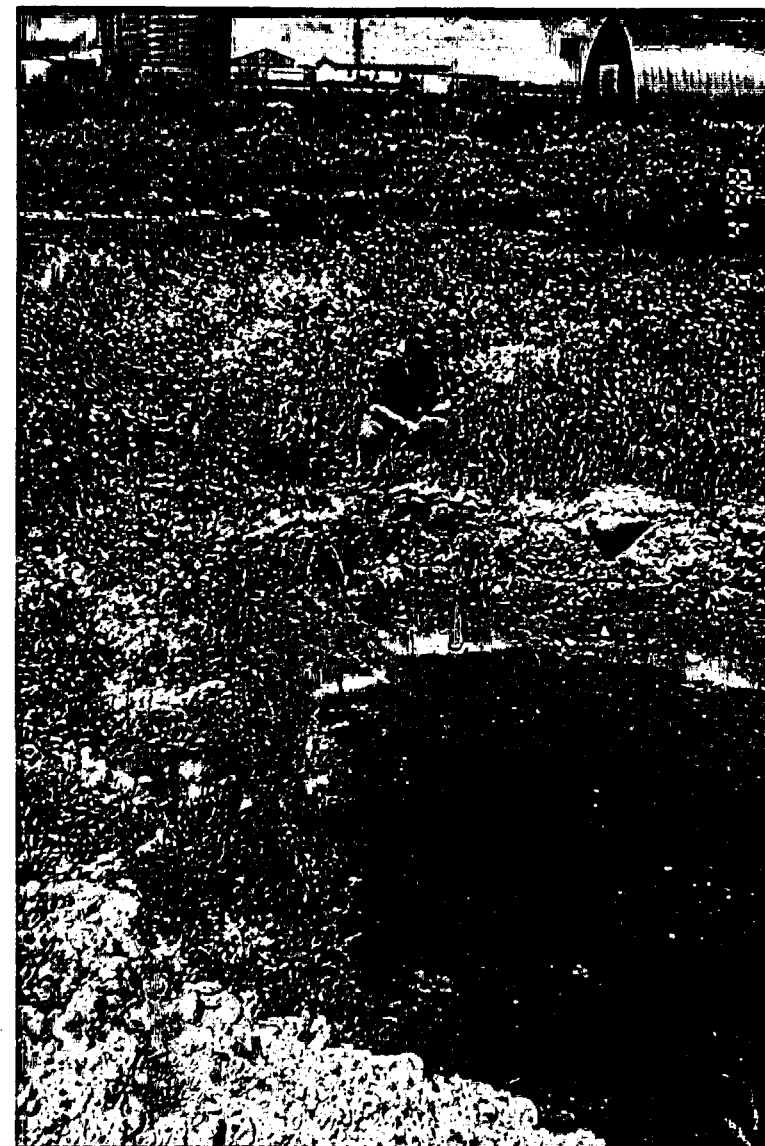
PHOTO 20

Facing south - RJ-SO-06 sample location near fire water pond where two drums were excavated.

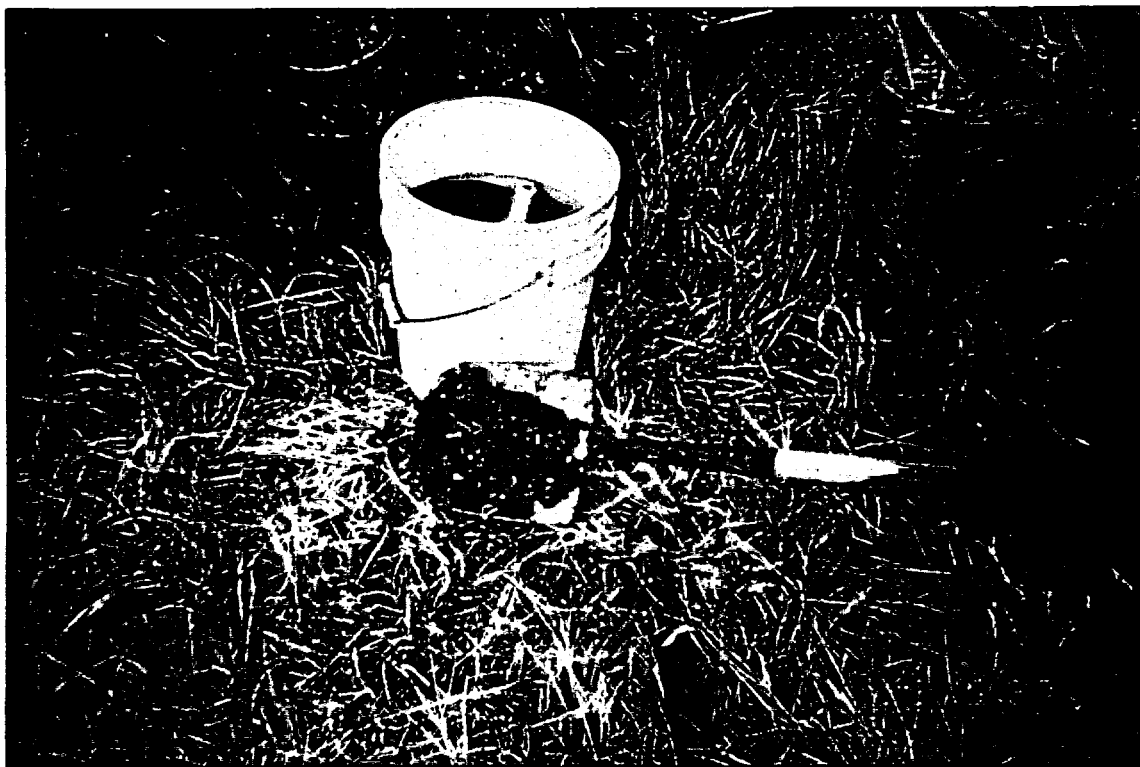
PHOTO 39

MW-1 stained soil from five to six feet below ground surface.

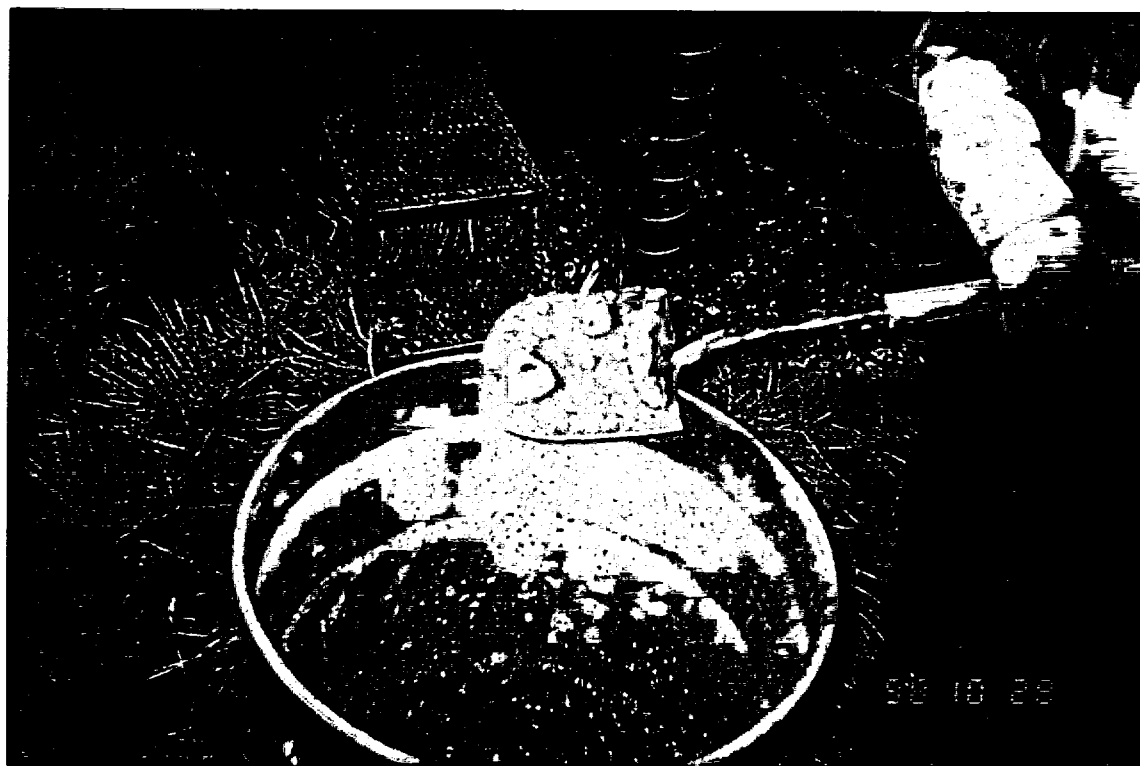
PHOTO 42
Silty gravel and cobbles at the location of MW-4.

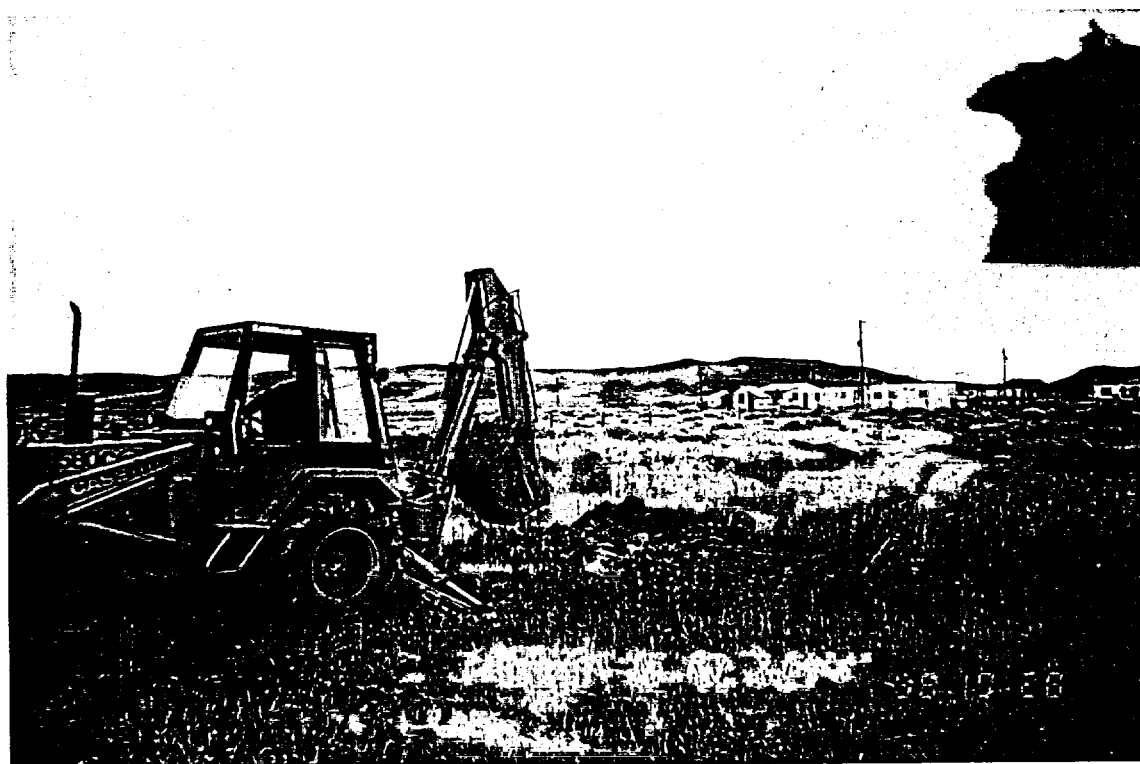
PHOTO 44

In addition ECC rented a backhoe for the purpose of digging test pits south of the fire water pond. Due to recent precipitation and resulting muddy conditions, only two test pits were excavated before abandoning this effort. No evidence of buried drums was encountered in the test pits.

Facing west-northwest, view of backhoe digging test pits on the west part of the site.
